Riprap Shoreline Protection Survey

Neskowin Coastal Hazards Committee

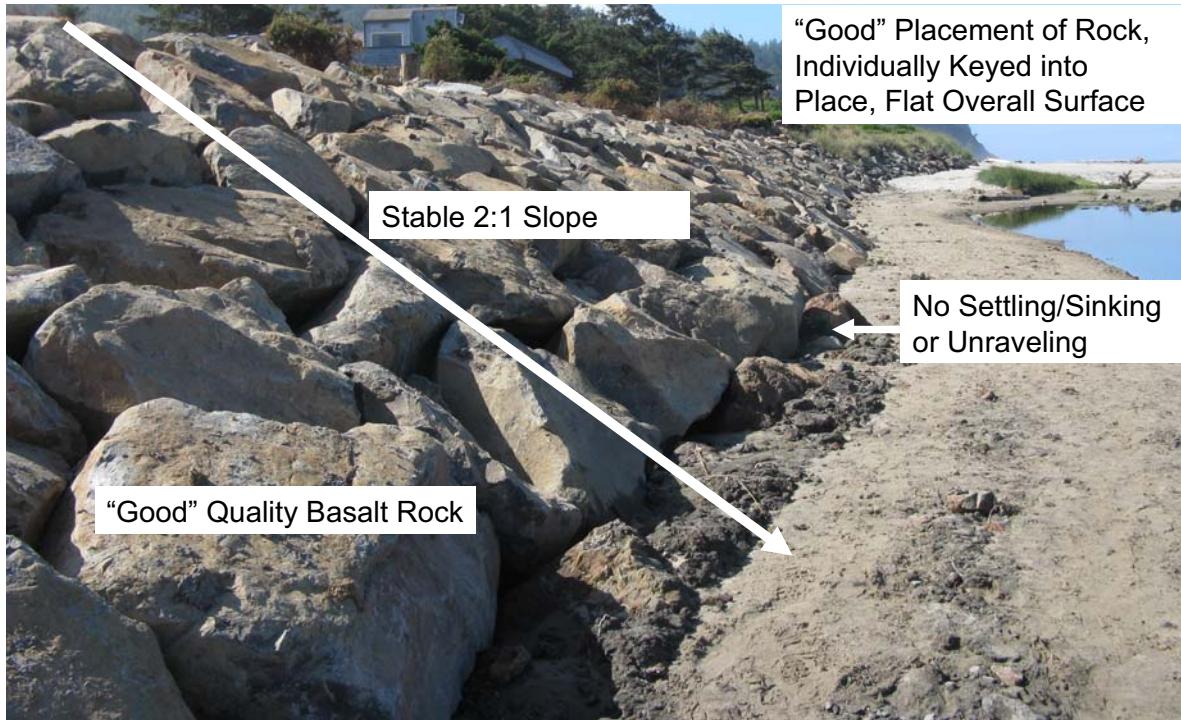
G = Good Condition:

**Rocks in place no settlement/sinking, no unraveling,
no rocks plucked out, good rock placement, rock quality good, overall structure
stable and functioning**

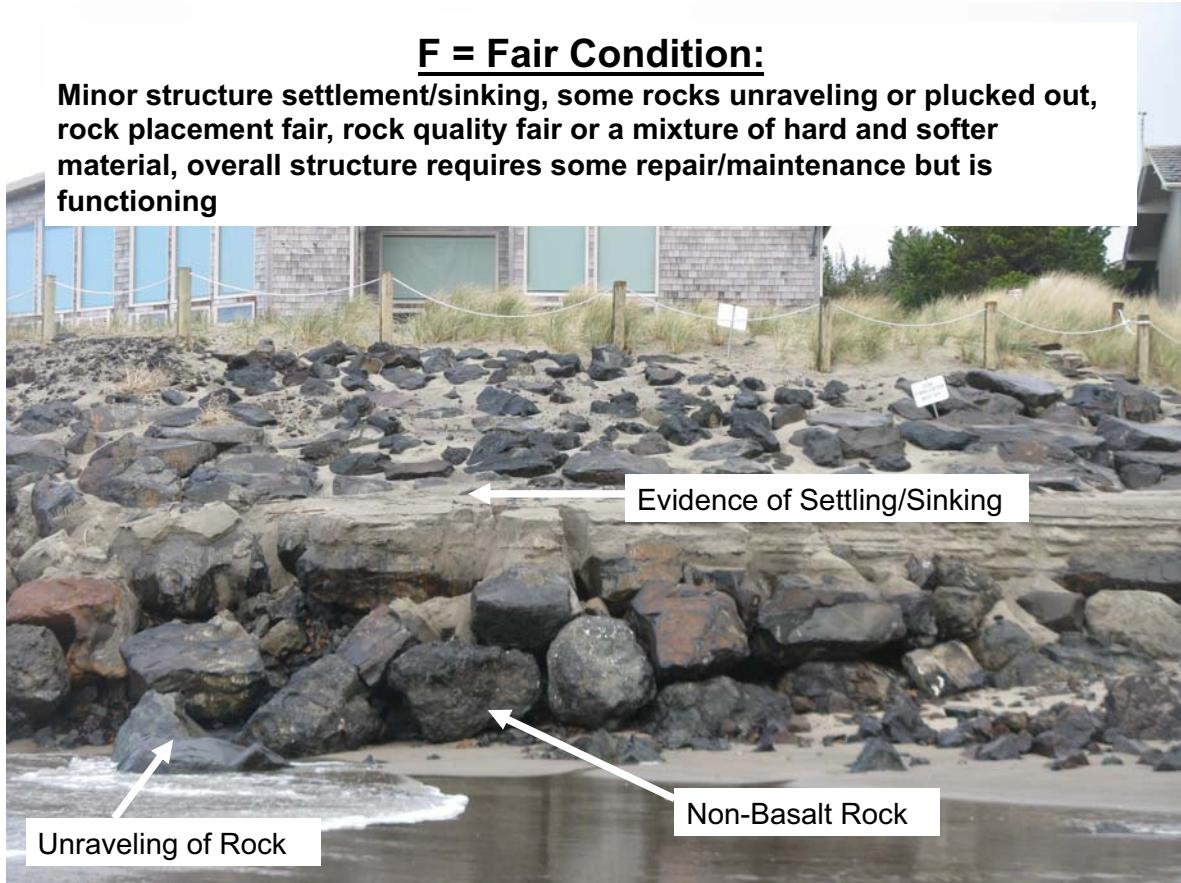
F = Fair Condition:

**Minor structure settlement/sinking, some rocks unraveling or plucked out,
rock placement fair, rock quality fair or a mixture of hard and softer
material, overall structure requires some repair/maintenance but is
functioning**

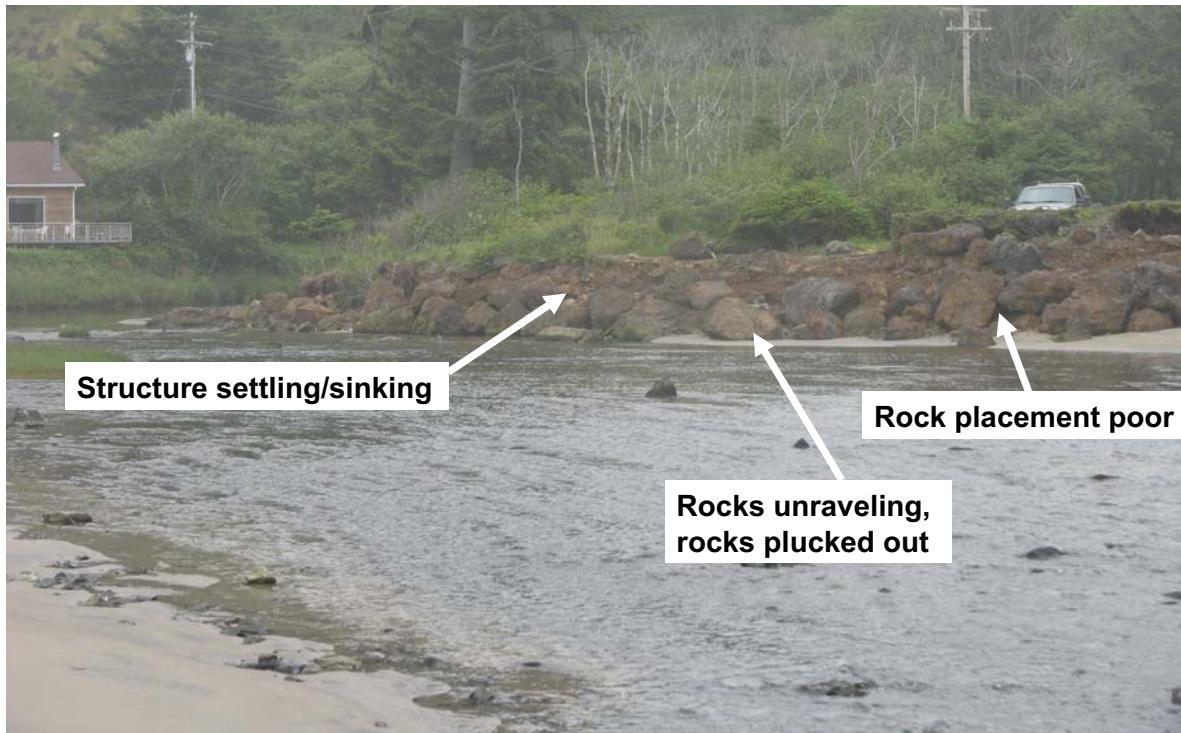
P = Poor Condition:

Structure settling/sinking, rocks unraveling , rocks plucked out, rock placement poor, rock quality fair, overall structure needs repair

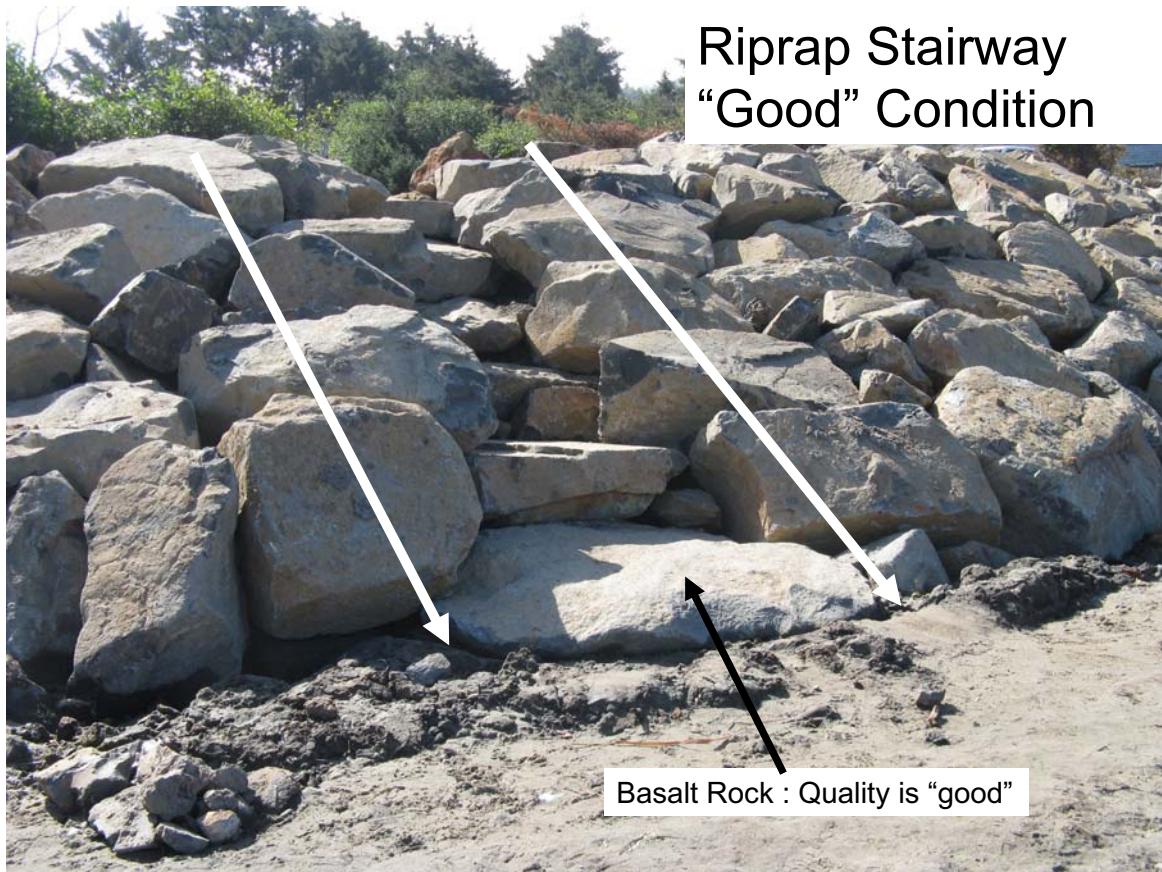
**Riprap Stairway
“Good” Condition**
