Riprap Shoreline Protection Survey

Neskowin Coastal Hazards Committee

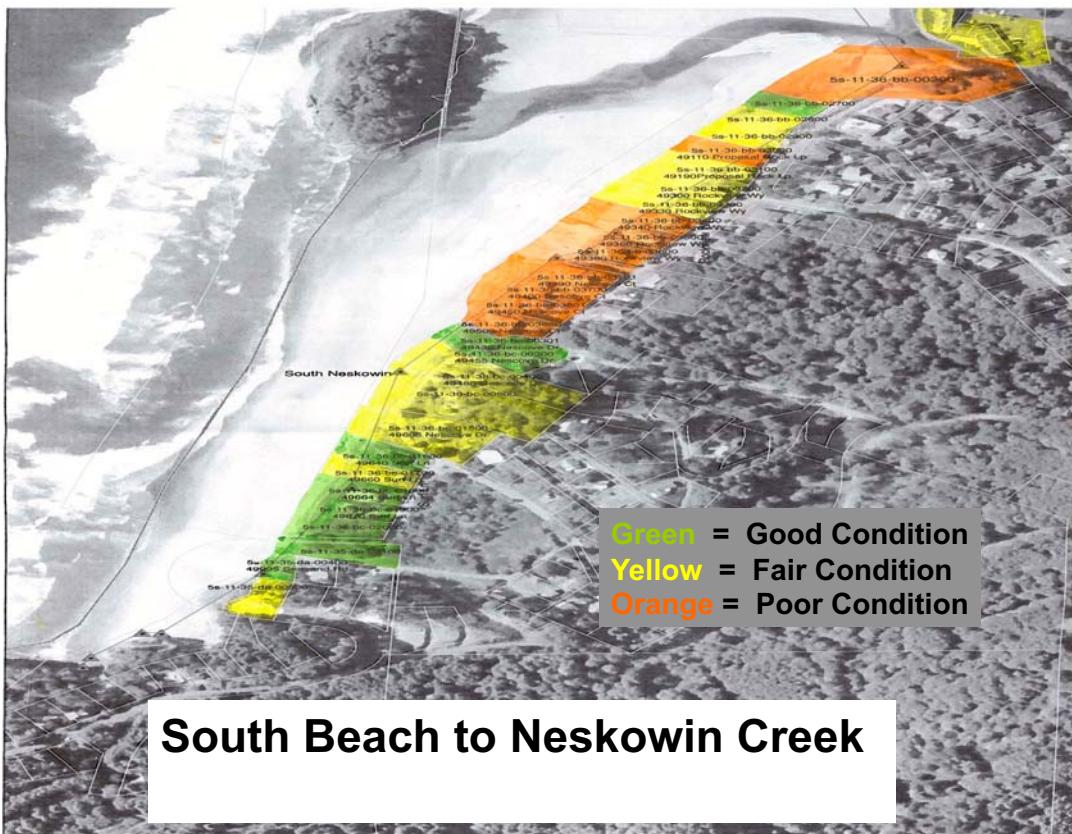
74 individual tax lots with riprap were surveyed

- *33 Tax Lots (GREEN) → Good Condition
- *30 Tax Lots (YELLOW) → Fair Condition
- *11 Tax Lots (ORANGE) → Poor Condition

85% percent of the structures were in fair to good condition

15% percent of the structures were in poor condition
